Manhole Inspection Summary

Manhole # S11S__019MH

Location Address: **810 S Canton Ave**

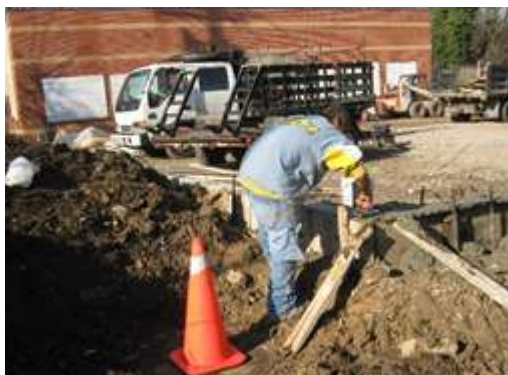
Location View

810 S. Caton Ave

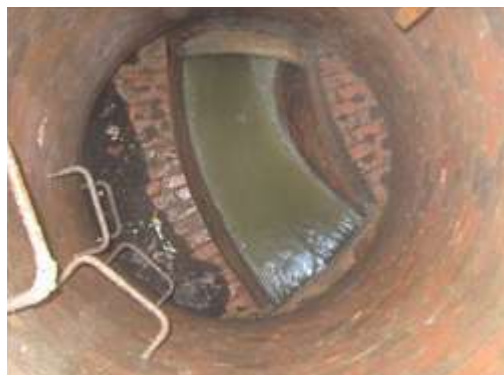
Top View

sediment on bench

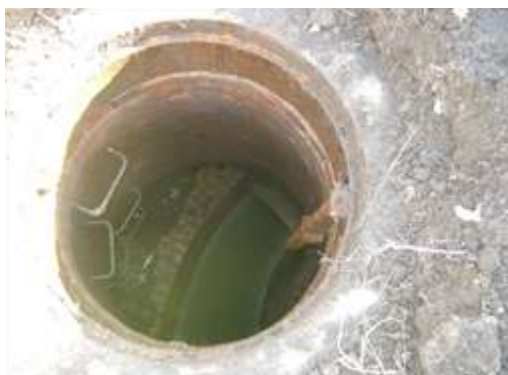
Frame View

mh cover

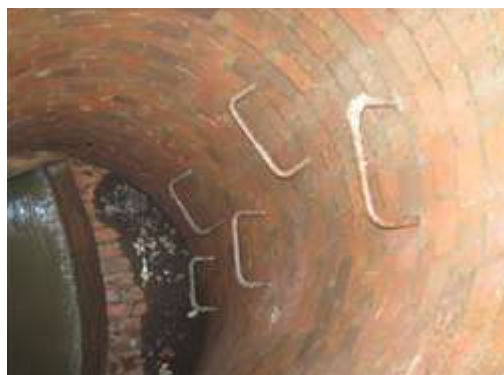
Defect 6

Steps Count: **5** Missing: **0** ☒ **Corroded**

corroded rungs

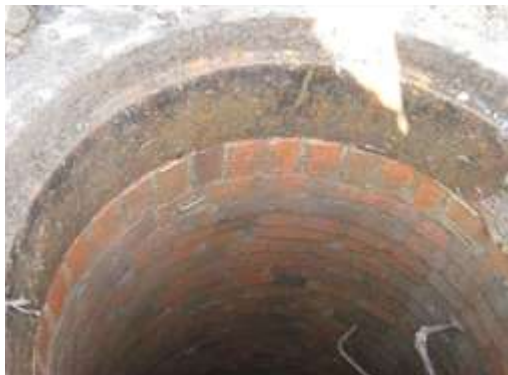
Defect 5

infiltration from top

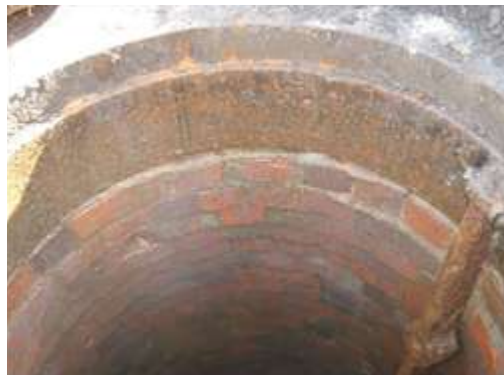
Defect 4

Condition: ☐ Sound ☐ Cracked ☐ Root Intrusion ☒ **Loose Brick** ☐ Deteriorated

gap at the joint (coded as loose bricks)

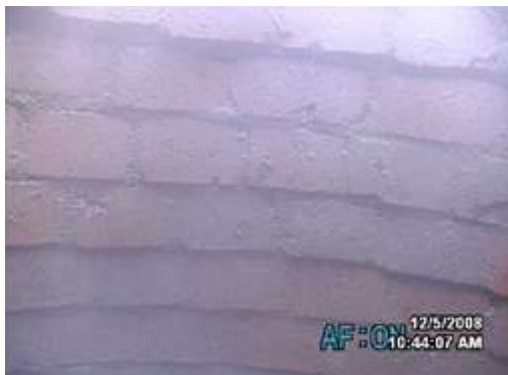
Defect 3

Infiltration: ☐ None ☐ Joint ☐ Cracks ☐ Mortar ☐ Roots ☒ **Wall**

infiltration cobrel wall

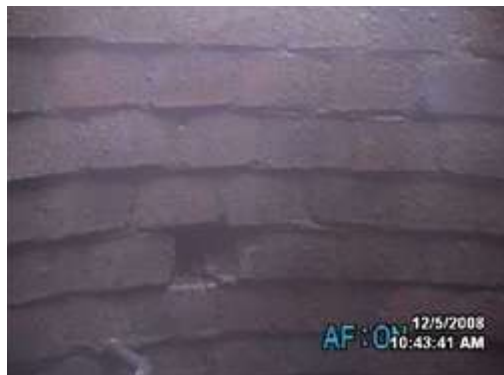
Defect 2

Condition: ☐ Sound ☐ Cracked ☐ Root Intrusion ☒ **Loose Brick** ☐ Deteriorated

missing brick in corbel wall

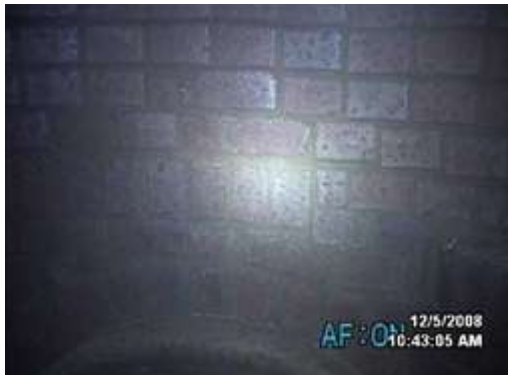
Defect 1

Infiltration: ☐ None ☐ Joint ☐ Cracks ☐ Mortar ☐ Roots ☒ **Wall**

infiltration barrel wall

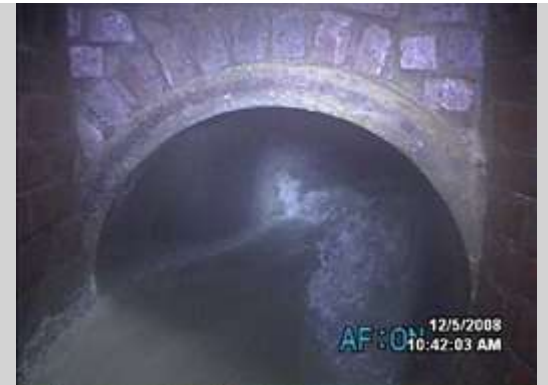
12 O'Clock Outflow

Pipe Height: **31.2** (in.) Rod and Bar (Angled)
Pipe Material: **Concrete** ☐ Pipe Lined
Invert Depth: **12.50** (ft.) Flow Characteristics: **Turbulent**
Deposits: ☒ None ☐ Mud ☐ Sludge ☐ Debris ☐ Grease
Silt Depth: **0** (in.) Deposits Extent:
Infiltration: **None** Pipe Seal Cond: **Sound**

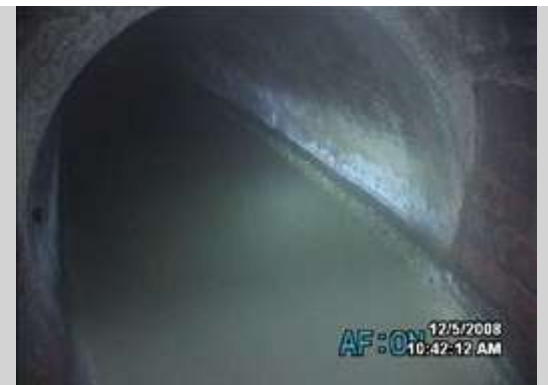
5 O'Clock Inflow

Pipe Height: **31.2** (in.) Rod and Bar (Angled)
Pipe Material: **Concrete** ☐ Pipe Lined
Invert Depth: **11.30** (ft.) Flow Characteristics: **Turbulent**
Deposits: ☒ None ☐ Mud ☐ Sludge ☐ Debris ☐ Grease
Silt Depth: **0** (in.) Deposits Extent:
Infiltration: **None** Pipe Seal Cond: **Sound**
